Uniform Mitigation Verification Inspection Form

Inspection Date: 3 - 9 - 2017		
Owner Information		
Owner Name: Forest Park 1 Condo's		Contact Person:
Address: Building # 2119.		Home Phone:
City: Dunedin	Zip: 34698	Work Phone:
County: Pinellas		Cell Phone:
Insurance Company:		Policy #:
Year of Home: 1984	# of Stories: Two	Email:

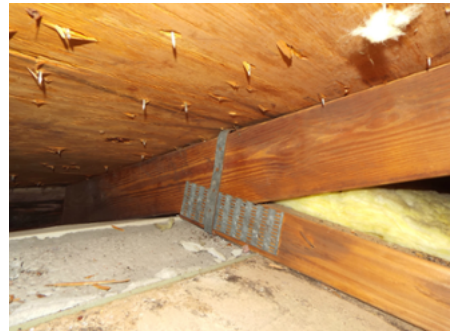
- A. Toe Nails
 - Truss/rafter anchored to top plate of wall using nails driven at an angle through the truss/rafter and attached to the top plate of the wall, or
 - Metal connectors that do not meet the minimal conditions or requirements of B, C, or D

Toe - Nail - only 2 nails

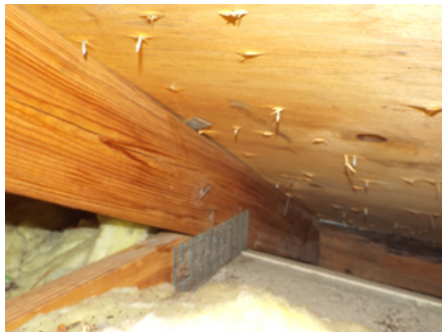
Toe - Nail - only 2 nails
