Uniform Mitigation Verification Inspection Form

Inspection Date: 3 - 9 - 2017		
Owner Information		
Owner Name: Forest Park 1 Condo's		Contact Person:
Address: Building # 2150		Home Phone:
City: Dunedin	Zip: 34698	Work Phone:
County: Pinellas		Cell Phone:
Insurance Company:		Policy #:
Year of Home: 1989	# of Stories: Two	Email:

Inspectors Initials DW Property Address Building # 2150

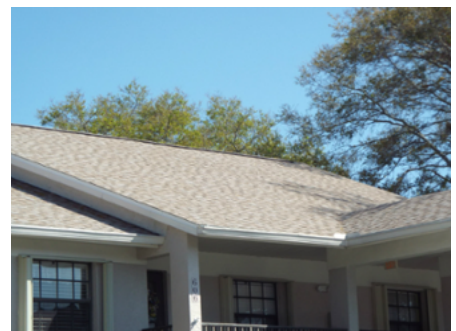
Roof - 1

2.1 Roof Covering Type:	Permit Application Date	FBC or MDC Product Approval #	Year of Original Installation or Replacement	No Information Provided for Compliance
<input checked="" type="checkbox"/> 1. Asphalt/Fiberglass Shingle	7 - 15 - 2016			<input type="checkbox"/>
<input type="checkbox"/> 2. Concrete/Clay Tile				<input type="checkbox"/>
<input type="checkbox"/> 3. Metal				<input type="checkbox"/>
<input type="checkbox"/> 4. Built Up				<input type="checkbox"/>
<input type="checkbox"/> 5. Membrane				<input type="checkbox"/>
<input type="checkbox"/> 6. Other _____				<input type="checkbox"/>

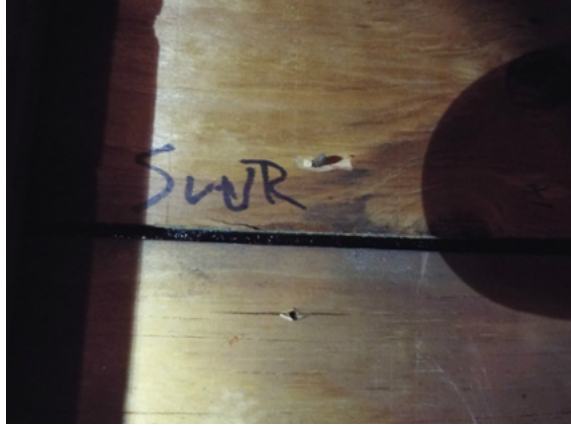
- A. SWR (also called Sealed Roof Deck) Self-adhering polymer modified-bitumen roofing underlayment applied directly to the sheathing or foam adhesive SWR barrier (not foamed-on insulation) applied as a supplemental means to protect the dwelling from water intrusion in the event of roof covering loss.
- B. No SWR.
- C. Unknown or undetermined.
