Windstorm Mitigation Report (OIR-B1-1802)

Forest Park Condominium Association, Inc. of Dunedin
2113 Elm St. Clubhouse
Dunedin, FL 34698

As of 02-06-2025 | FPAT File# MUD2319585

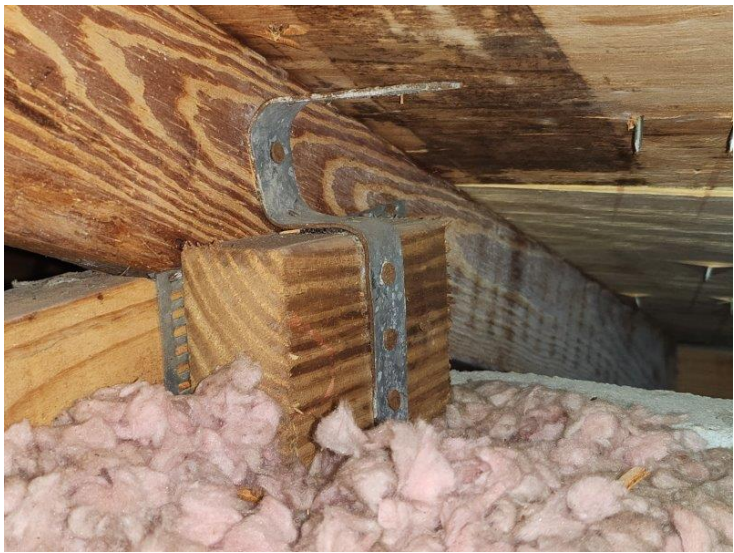
Roof Construction

Comments: | Level C
Inspection verified 1/2" plywood roof deck attached with 8d nails at a minimum 6" on the edge & 6" in the field. |

Comments: | Clips
Inspection verified embedded straps fastened with a minimum of three nails. |

Comments: | Yes
SWR was verified at time of inspection. The Secondary Water Resistance verified is a self-adhering peel and stick. |
