Windstorm Mitigation Report (OIR-B1-1802)

Forest Park Condominium Association, Inc. of Dunedin
2119 Elm St. Units 101-112
Dunedin, FL 34698

As of 02-06-2025 | FPAT File# MUD2319585

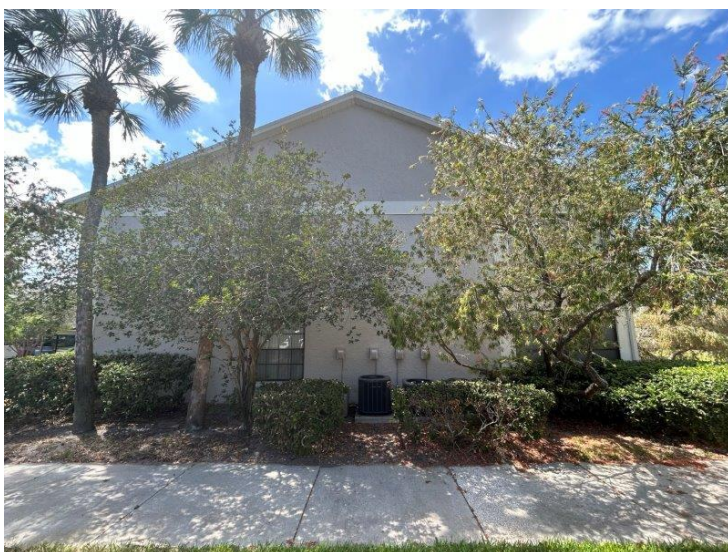
Exterior Elevation

Comments: | Other Roof
Inspection verified a gable roof shape. |
