Windstorm Mitigation Report (OIR-B1-1802)

Forest Park Condominium Association, Inc. of Dunedin
2129 Elm St. Units 201-208
Dunedin, FL 34698

As of 02-06-2025 | FPAT File# MUD2319585

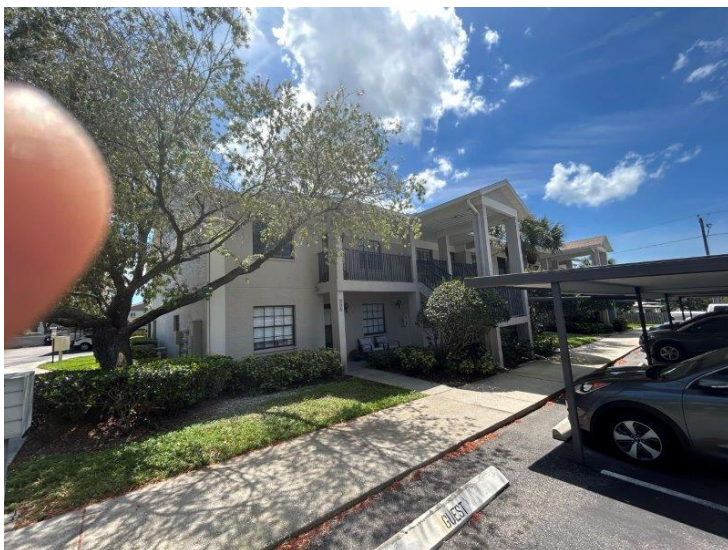
Exterior Elevation

Comments: | Other Roof
Inspection verified a gable roof shape. |

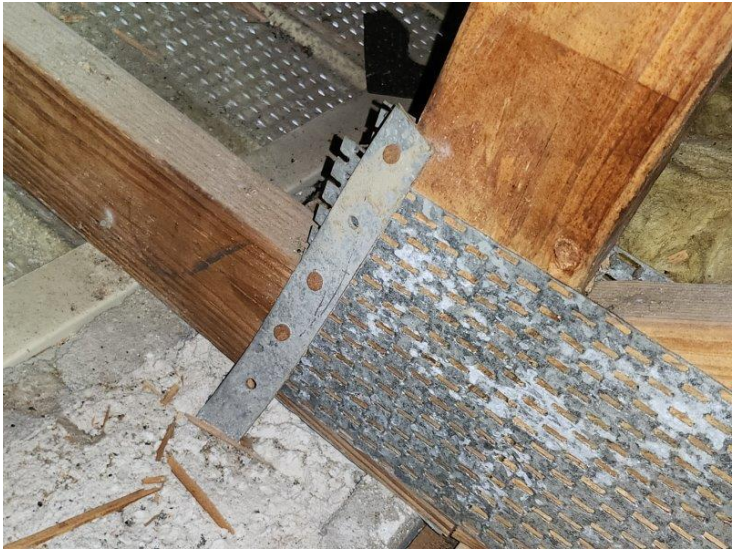
Roof Construction

Comments: | Level C
Inspection verified 1/2" plywood roof deck attached with 8d nails at a minimum 6" on the edge & 6" in the field. |

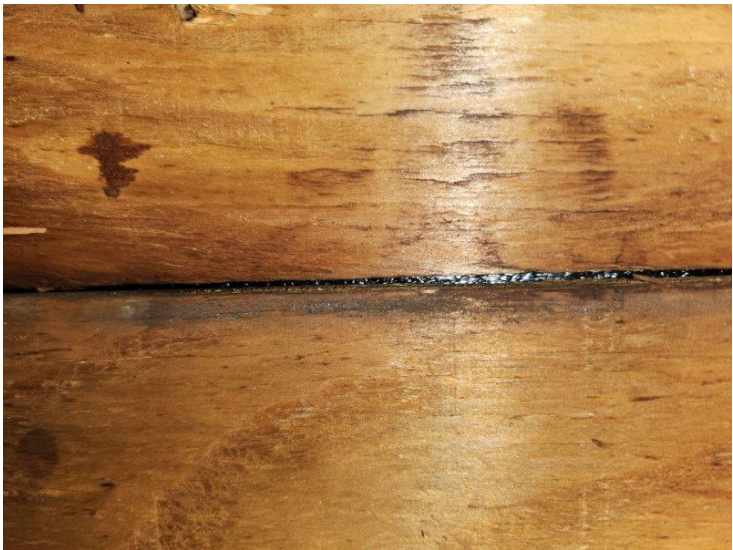
Comments: | Clips
Inspection verified embedded straps fastened with a minimum of three nails |

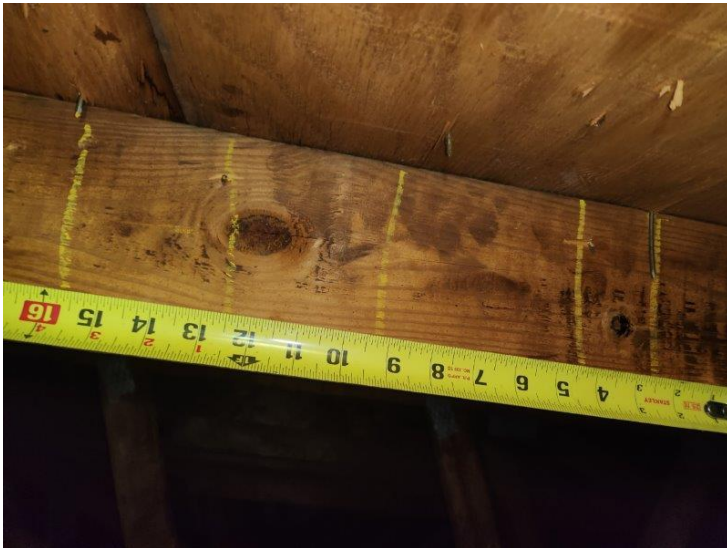
Roof Construction

Comments: | Yes
SWR was verified at time of inspection. The Secondary Water Resistance verified is a self-adhering peel and stick. |
