Windstorm Mitigation Report (OIR-B1-1802)

Forest Park Condominium Association, Inc. of Dunedin
2139 Elm St. Units 301-308
Dunedin, FL 34698

As of 02-06-2025 | FPAT File# MUD2319585

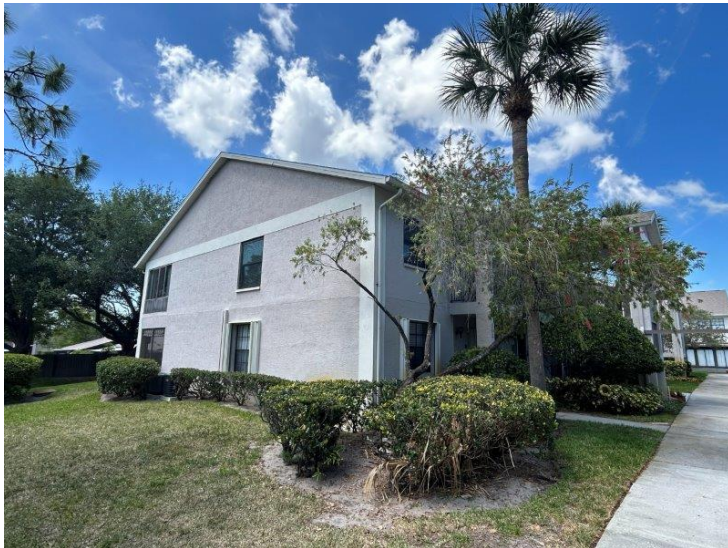
Exterior Elevation

Comments: | Other Roof
Inspection verified a gable roof shape |

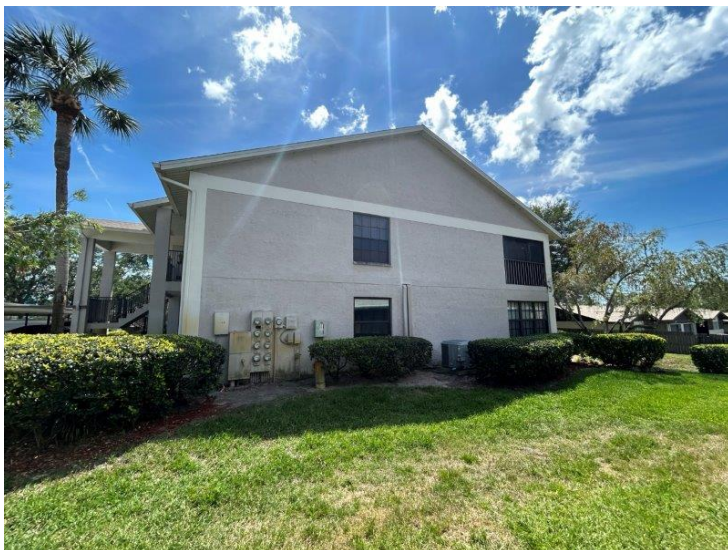
Exterior Elevation

Comments: | None or Some Glazed Openings
Inspection verified some opening protection. Not all glazed openings were protected with impact resistant coverings. |

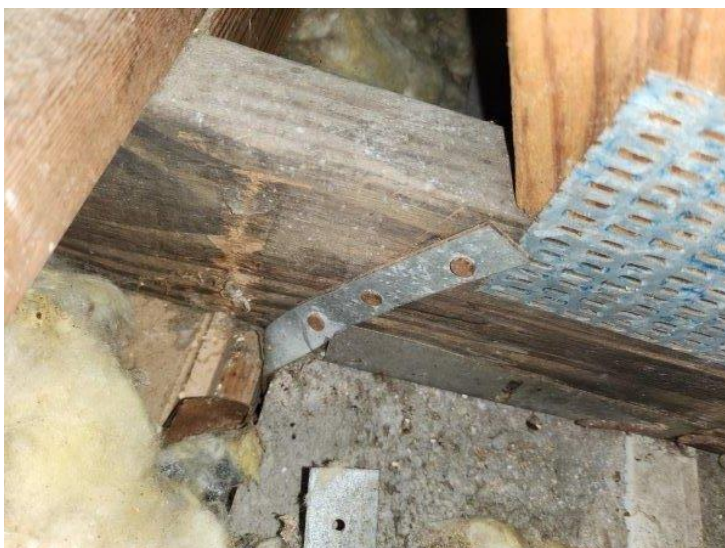
Roof Construction

Comments: | Level C
Inspection verified 1/2" plywood roof deck attached with 8d nails at a minimum 6" on the edge & 6" in the field. |

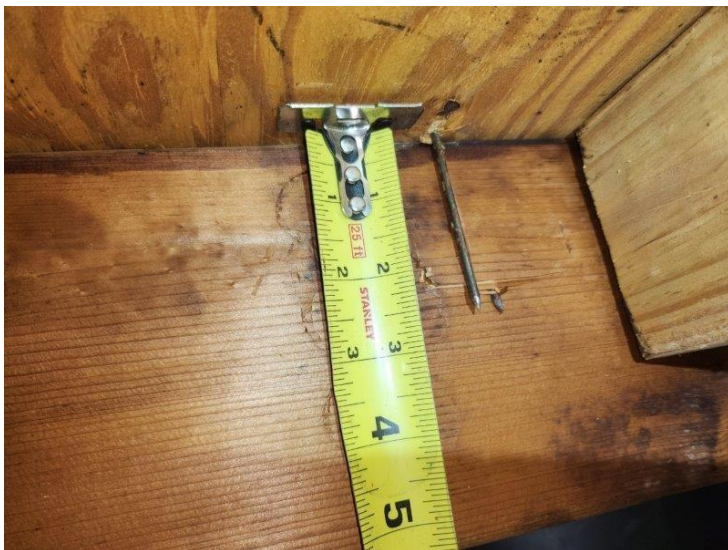
Roof Construction

Comments: | Toe Nails
Inspection verified embedded straps fastened with less than three nails |
