COMMERCIAL WINDSTORM MITIGATION REPORT (OIR-B1-1802)

Forest Park Condominium Association, Inc. of Dunedin

2170 Elm St, Units 901-908

As of 6/17/2019

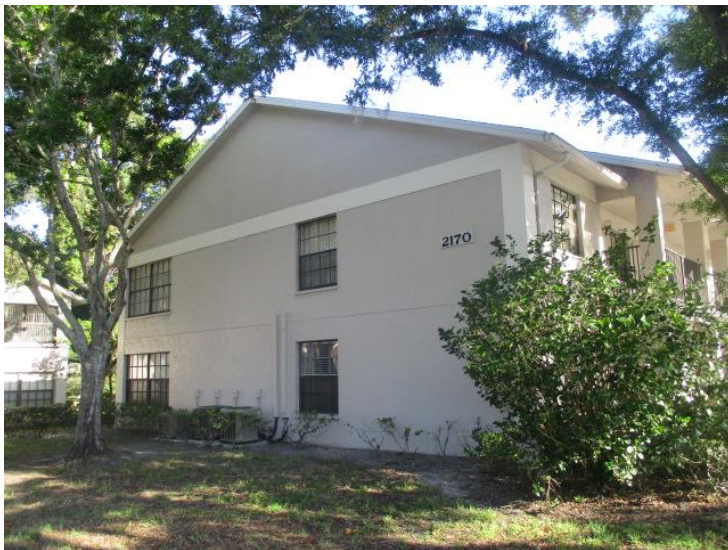
Exterior Elevation

4. **Roof to Wall Attachment:** **Toe Nails**
Comments: Inspection verified embedded straps fastened with less than three nails.
5. **Roof Geometry:** **Other Roof**
Comments: Inspection verified a gable roof shape.

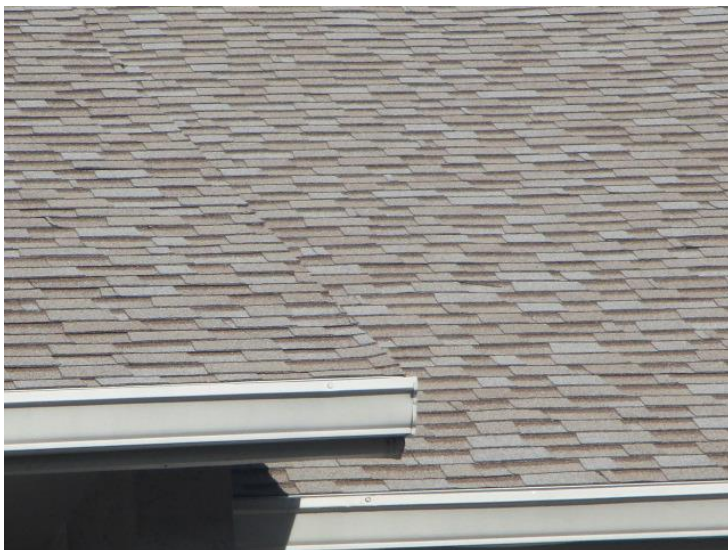
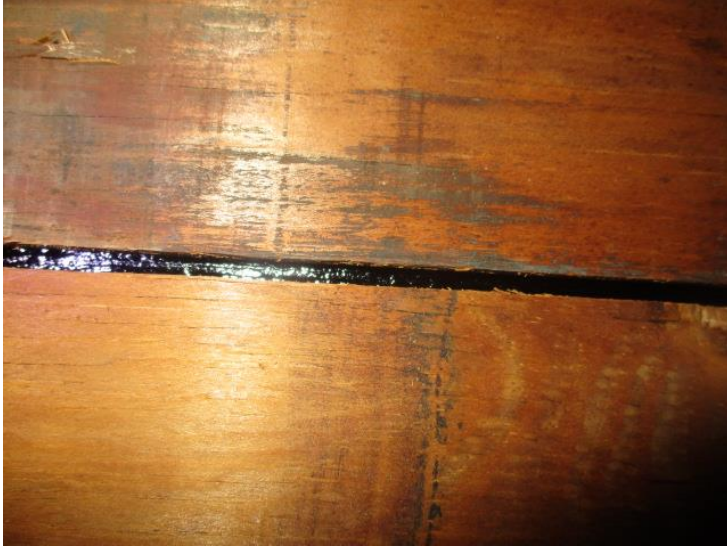
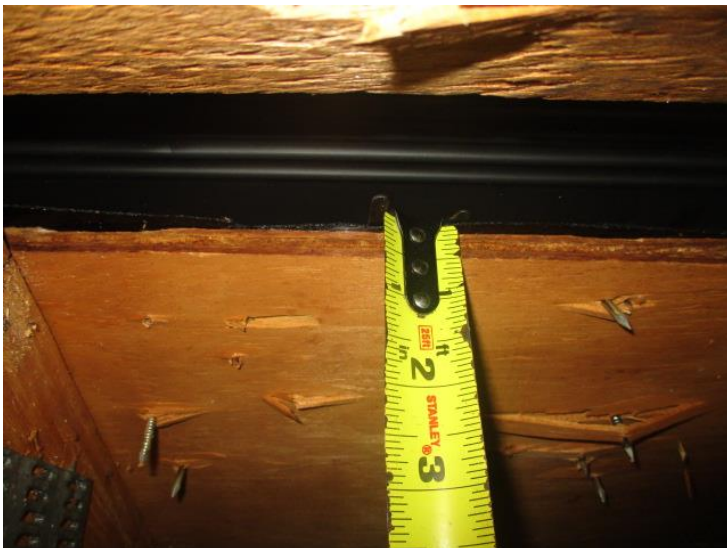
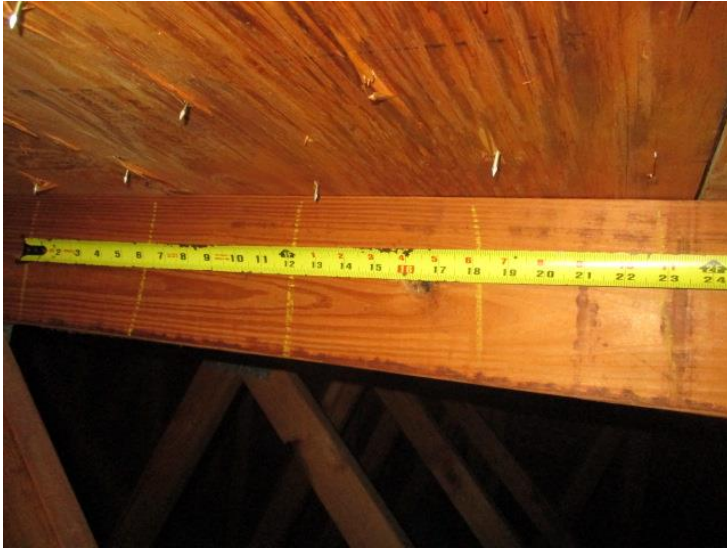
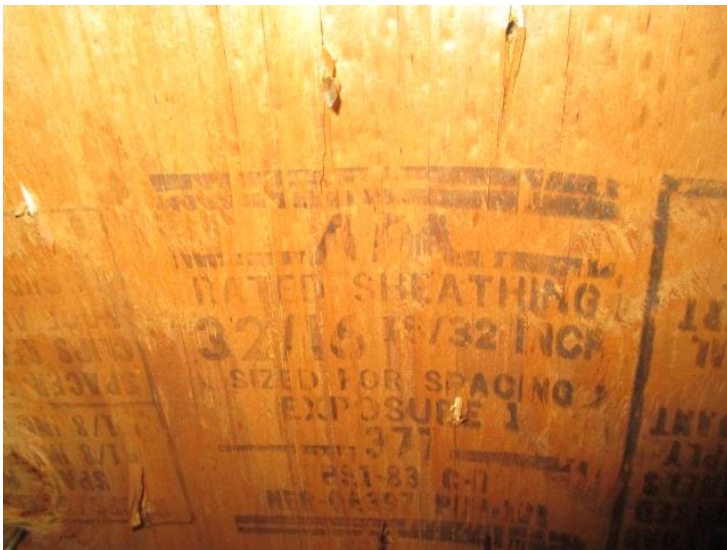
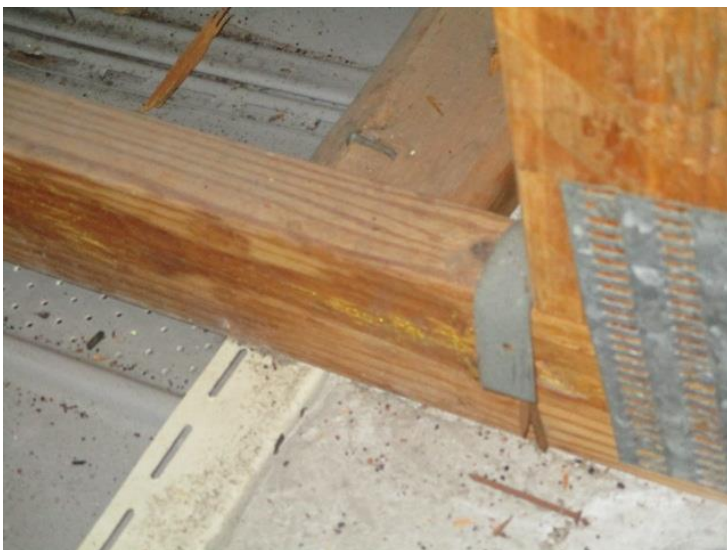
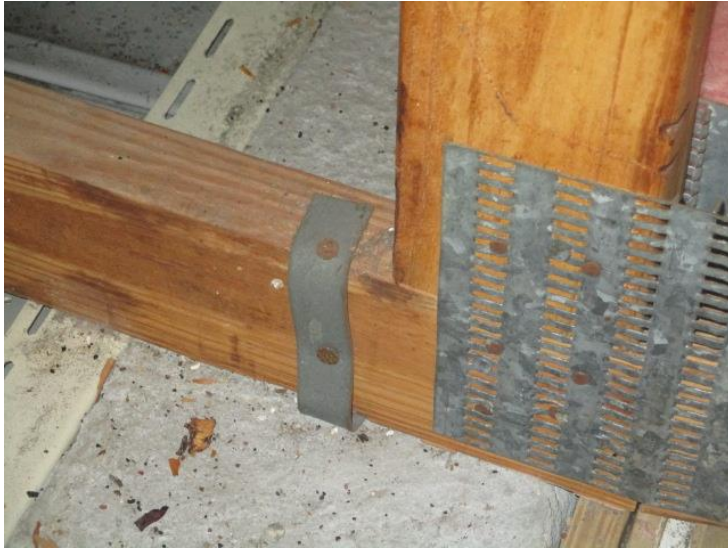
Roof Construction

3. **Roof Deck Attachment:** **Level C**
Comments: Inspection verified 1/2" plywood roof deck attached with 8d nails at a minimum 6" on the edge & 6" in the field.

6. **SWR:** **Yes**
Comments: SWR was verified at time of inspection. The Secondary Water Resistance verified is a self-adhering peel and stick.
7. **Opening Protection:** **None or Some Glazed Openings**
Comments: Inspection verified some metal shutter opening protection. Not all glazed openings were protected with impact resistant coverings.
