Uniform Mitigation Verification Inspection Form

Inspection Date: 3 - 9 - 2017		
Owner Information		
Owner Name: Forest Park 1 Condo's		Contact Person:
Address: Building # 2129		Home Phone:
City: Dunedin	Zip: 34698	Work Phone:
County: Pinellas		Cell Phone:
Insurance Company:		Policy #:
Year of Home: 1986	# of Stories: Two	Email:

Inspectors Initials DW Property Address Building # 2129

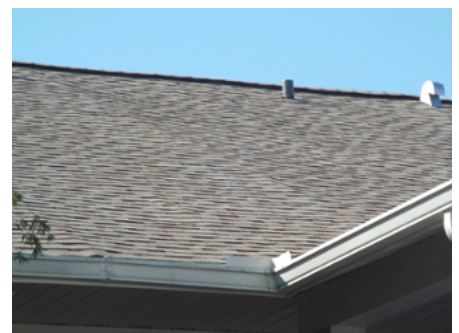
Roof - 1

2.1 Roof Covering Type:	Permit Application Date	FBC or MDC Product Approval #	Year of Original Installation or Replacement	No Information Provided for Compliance
<input checked="" type="checkbox"/> 1. Asphalt/Fiberglass Shingle	7 - 15 - 2016			<input type="checkbox"/>
<input type="checkbox"/> 2. Concrete/Clay Tile				<input type="checkbox"/>
<input type="checkbox"/> 3. Metal				<input type="checkbox"/>
<input type="checkbox"/> 4. Built Up				<input type="checkbox"/>
<input type="checkbox"/> 5. Membrane				<input type="checkbox"/>
<input type="checkbox"/> 6. Other _____				<input type="checkbox"/>

- ☒ A. All roof coverings listed above meet the FBC with a FBC or Miami-Dade Product Approval listing current at time of installation OR have a roofing permit application date on or after 3/1/02 OR the roof is original and built in 2004 or later.
- ☐ B. All roof coverings have a Miami-Dade Product Approval listing current at time of installation OR (for the HVHZ only) a roofing permit application after 9/1/1994 and before 3/1/2002 OR the roof is original and built in 1997 or later.
- ☐ C. One or more roof coverings do not meet the requirements of Answer "A" or "B".
- ☐ D. No roof coverings meet the requirements of Answer "A" or "B".

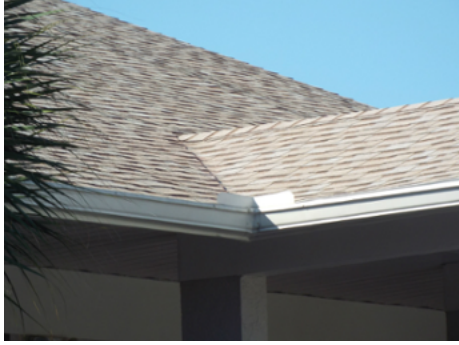
Roof - 2

- ☐ A. Hip Roof Hip roof with no other roof shapes greater than 10% of the total roof system perimeter.
Total length of non-hip features: _____ feet; Total roof system perimeter: _____ feet
- ☐ B. Flat Roof Roof on a building with 5 or more units where at least 90% of the main roof area has a roof slope of less than 2:12. Roof area with slope less than 2:12 _____ sq ft; Total roof area _____ sq ft
- ☒ C. Other Roof Any roof that does not qualify as either (A) or (B) above.

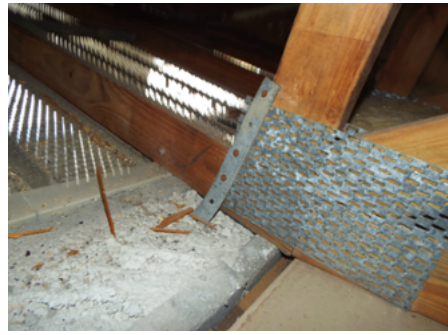
Clip

- ☒ Secured to truss/rafter with a minimum of three (3) nails, **and**
- ☒ Attached to the wall top plate of the wall framing, or embedded in the bond beam, with less than a 1/2" gap from the blocking or truss/rafter **and** blocked no more than 1.5" of the truss/rafter, **and** free of visible severe corrosion.
- ☒ B. Clips
 - ☒ Metal connectors that do not wrap over the top of the truss/rafter, **or**
 - ☐ Metal connectors with a minimum of 1 strap that wraps over the top of the truss/rafter and does not meet the nail position requirements of C or D, but is secured with a minimum of 3 nails.
- ☐ C. Single Wraps

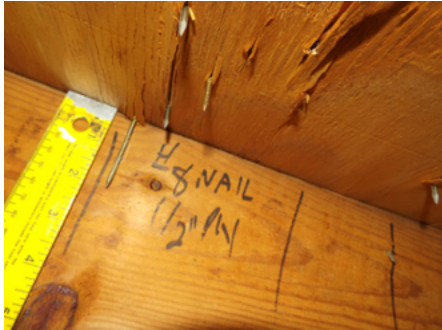
Nail Length

- ☒ C. Plywood/OSB roof sheathing with a minimum thickness of 7/16" inch attached to the roof truss/rafter (spaced a maximum of 24" inches o.c.) by 8d common nails spaced a maximum of 6" inches in the field. -OR- Dimensional lumber/Tongue & Groove decking with a minimum of 2 nails per board (or 1 nail per board if each board is equal to or less than 6 inches in width). -OR-

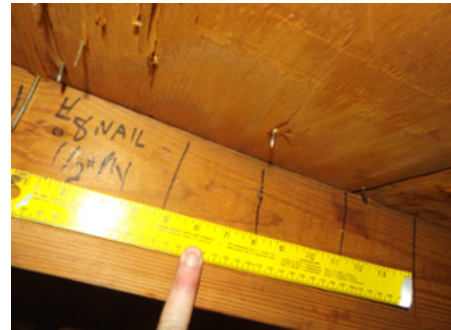
Nail Spacing

Any system of screws, nails, adhesives, other deck fastening system or truss/rafter spacing that is shown to have an equivalent or greater resistance than 8d common nails spaced a maximum of 6 inches in the field or has a mean uplift resistance of at least 182 psf.

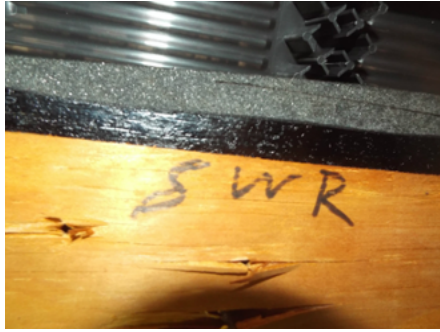
- ☒ A. SWR (also called Sealed Roof Deck) Self-adhering polymer modified-bitumen roofing underlayment applied directly to the sheathing or foam adhesive SWR barrier (not foamed-on insulation) applied as a supplemental means to protect the dwelling from water intrusion in the event of roof covering loss.
- ☐ B. No SWR.
- ☐ C. Unknown or undetermined.
