Uniform Mitigation Verification Inspection Form

Inspection Date: 3 - 9 - 2017		
Owner Information		
Owner Name: Forest Park 1 Condo's		Contact Person:
Address: Building # 2139		Home Phone:
City: Dunedin	Zip: 34698	Work Phone:
County: Pinellas		Cell Phone:
Insurance Company:		Policy #:
Year of Home: 1987	# of Stories: Two	Email:

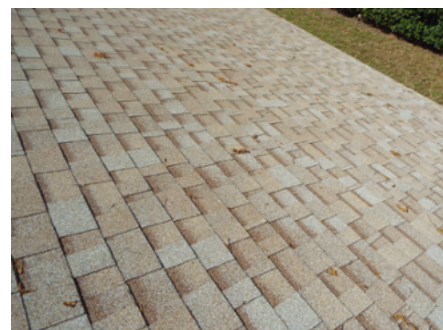
Roof - 1

2.1 Roof Covering Type:	Permit Application Date	FBC or MDC Product Approval #	Year of Original Installation or Replacement	No Information Provided for Compliance
<input checked="" type="checkbox"/> 1. Asphalt/Fiberglass Shingle	7 - 15 - 2016			<input type="checkbox"/>
<input type="checkbox"/> 2. Concrete/Clay Tile				<input type="checkbox"/>
<input type="checkbox"/> 3. Metal				<input type="checkbox"/>
<input type="checkbox"/> 4. Built Up				<input type="checkbox"/>
<input type="checkbox"/> 5. Membrane				<input type="checkbox"/>
<input type="checkbox"/> 6. Other				<input type="checkbox"/>

- ☒ A. All roof coverings listed above meet the FBC with a FBC or Miami-Dade Product Approval listing current at time of installation OR have a roofing permit application date on or after 3/1/02 OR the roof is original and built in 2004 or later.
☐ B. All roof coverings have a Miami-Dade Product Approval listing current at time of installation OR (for the HVHZ only) a roofing permit application after 9/1/1994 and before 3/1/2002 OR the roof is original and built in 1997 or later.
☐ C. One or more roof coverings do not meet the requirements of Answer "A" or "B".
☐ D. No roof coverings meet the requirements of Answer "A" or "B".

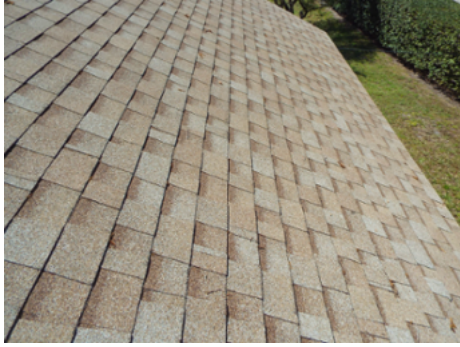
Roof - 2

- ☐ A. Hip Roof Hip roof with no other roof shapes greater than 10% of the total roof system perimeter.
Total length of non-hip features: _____ feet; Total roof system perimeter: _____ feet
- ☐ B. Flat Roof Roof on a building with 5 or more units where at least 90% of the main roof area has a roof slope of less than 2:12. Roof area with slope less than 2:12 _____ sq ft; Total roof area _____ sq ft
- ☒ C. Other Roof Any roof that does not qualify as either (A) or (B) above.

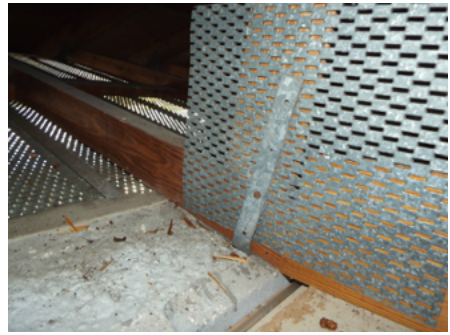
- ☒ A. Toe Nails
 - ☐ Truss/rafter anchored to top plate of wall using nails driven at an angle through the truss/rafter and attached to the top plate of the wall, or
 - ☒ Metal connectors that do not meet the minimal conditions or requirements of B, C, or D

Toe - Nail - only 2 nails

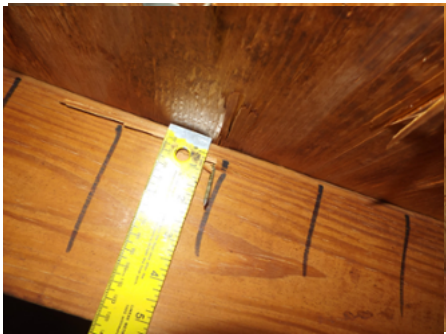
☒ C. Plywood/OSB roof sheathing with a minimum thickness of 7/16" inch attached to the roof truss/rafter (spaced a maximum of 24" inches o.c.) by 8d common nails spaced a maximum of 6" inches in the field. -OR- Dimensional lumber/Tongue & Groove decking with a minimum of 2 nails per board (or 1 nail per board if each board is equal to or less than 6 inches in width). -OR-

Nail Length

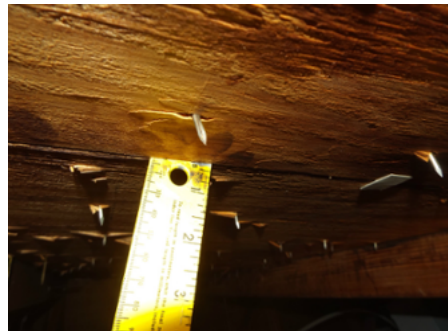
Plywood Width

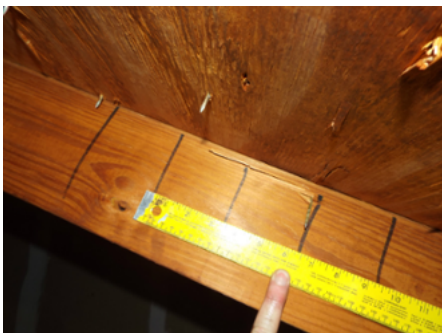
Nail Spacing

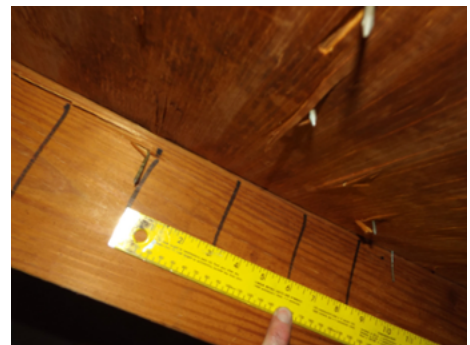
Nail Spacing - 2

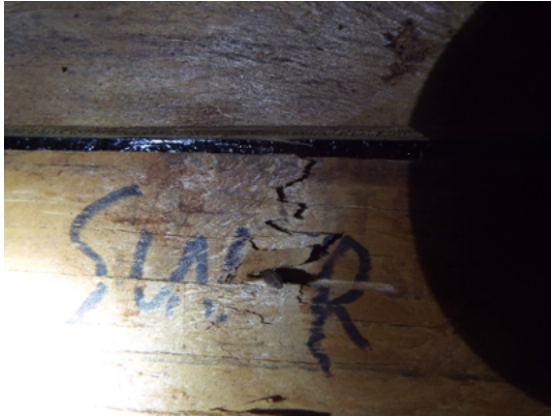
- ☒ A. SWR (also called Sealed Roof Deck) Self-adhering polymer modified-bitumen roofing underlayment applied directly to the sheathing or foam adhesive SWR barrier (not foamed-on insulation) applied as a supplemental means to protect the dwelling from water intrusion in the event of roof covering loss.
- ☐ B. No SWR.
- ☐ C. Unknown or undetermined.

SWR
