Uniform Mitigation Verification Inspection Form

Inspection Date: 3 - 9 - 2017		
Owner Information		
Owner Name: Forest Park 1 Condo's		Contact Person:
Address: Building # 2188		Home Phone:
City: Dunedin	Zip: 34698	Work Phone:
County: Pinellas		Cell Phone:
Insurance Company:		Policy #:
Year of Home: 1986	# of Stories: Two	Email:

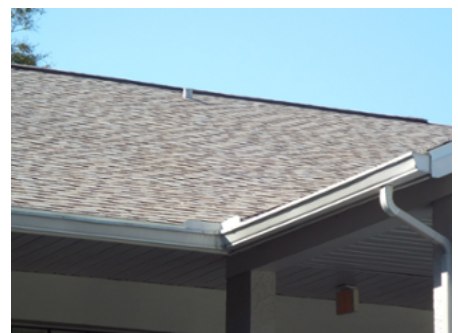
Roof - 1

2.1 Roof Covering Type:	Permit Application Date	FBC or MDC Product Approval #	Year of Original Installation or Replacement	No Information Provided for Compliance
<input checked="" type="checkbox"/> 1. Asphalt/Fiberglass Shingle	7 - 15 - 2016			<input type="checkbox"/>
<input type="checkbox"/> 2. Concrete/Clay Tile				<input type="checkbox"/>
<input type="checkbox"/> 3. Metal				<input type="checkbox"/>
<input type="checkbox"/> 4. Built Up				<input type="checkbox"/>
<input type="checkbox"/> 5. Membrane				<input type="checkbox"/>
<input type="checkbox"/> 6. Other _____				<input type="checkbox"/>

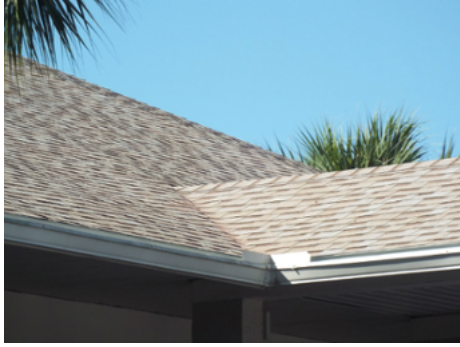
Roof - 2

- ☐ A. Hip Roof Hip roof with no other roof shapes greater than 10% of the total roof system perimeter.
Total length of non-hip features: _____ feet; Total roof system perimeter: _____ feet
- ☐ B. Flat Roof Roof on a building with 5 or more units where at least 90% of the main roof area has a roof slope of less than 2:12. Roof area with slope less than 2:12 _____ sq ft; Total roof area _____ sq ft
- ☒ C. Other Roof Any roof that does not qualify as either (A) or (B) above.

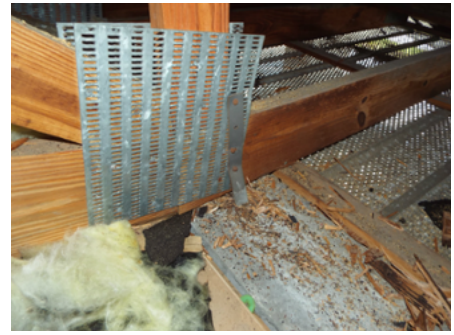
Clip

- ☒ Secured to truss/rafter with a minimum of three (3) nails, **and**
- ☒ Attached to the wall top plate of the wall framing, or embedded in the bond beam, with less than a 1/2" gap from the blocking or truss/rafter **and** blocked no more than 1.5" of the truss/rafter, **and** free of visible severe corrosion.
- ☒ B. Clips
 - ☒ Metal connectors that do not wrap over the top of the truss/rafter, **or**
 - ☐ Metal connectors with a minimum of 1 strap that wraps over the top of the truss/rafter and does not meet the nail position requirements of C or D, but is secured with a minimum of 3 nails.
- ☐ C. Single Wraps

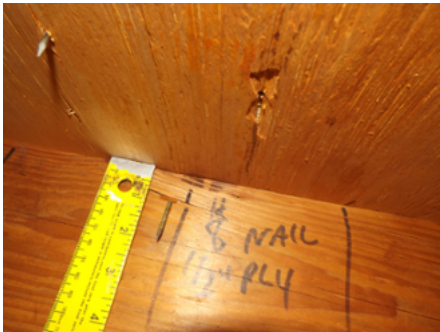
Nail Length

- ☒ C. Plywood/OSB roof sheathing with a minimum thickness of 7/16" inch attached to the roof truss/rafter (spaced a maximum of 24" inches o.c.) by 8d common nails spaced a maximum of 6" inches in the field. -OR- Dimensional lumber/Tongue & Groove decking with a minimum of 2 nails per board (or 1 nail per board if each board is equal to or less than 6 inches in width). -OR-

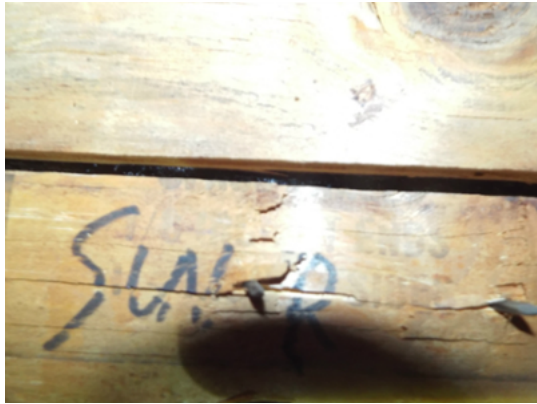
- ☒ A. SWR (also called Sealed Roof Deck) Self-adhering polymer modified-bitumen roofing underlayment applied directly to the sheathing or foam adhesive SWR barrier (not foamed-on insulation) applied as a supplemental means to protect the dwelling from water intrusion in the event of roof covering loss.
- ☐ B. No SWR.
- ☐ C. Unknown or undetermined.
