Windstorm Mitigation Report (OIR-B1-1802)

Forest Park Condominium Association, Inc. of Dunedin
2130 Elm St, Units 401-408
Dunedin, FL 34698

As of 04-07-2023 | FPAT File# MUD2319585

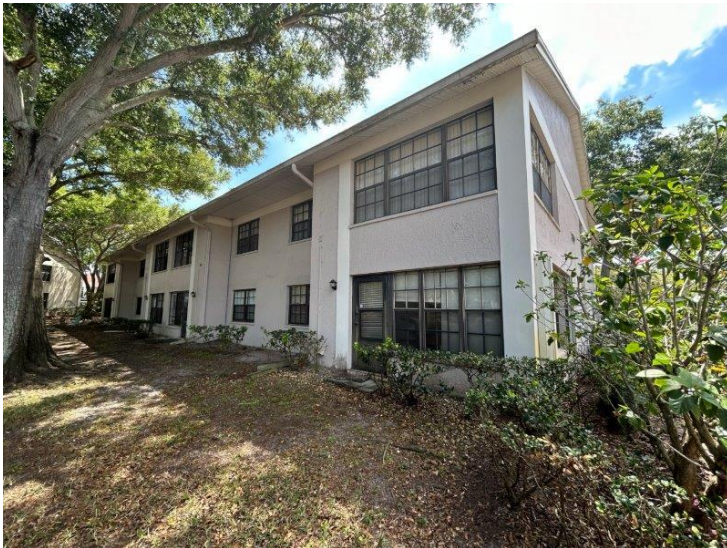
Exterior Elevation

Comments: | Other Roof
Inspection verified a gable roof shape. |

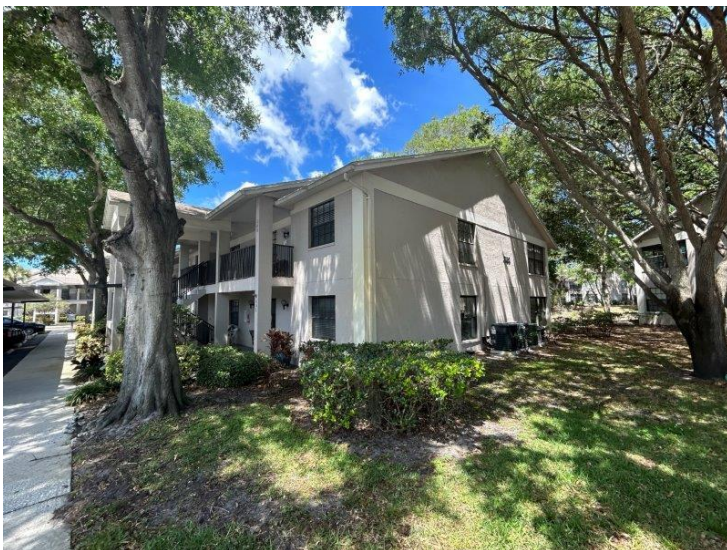
Exterior Elevation

Comments: | None or Some Glazed Openings
Inspection verified some opening protection. Not all glazed openings were protected with impact resistant coverings. |

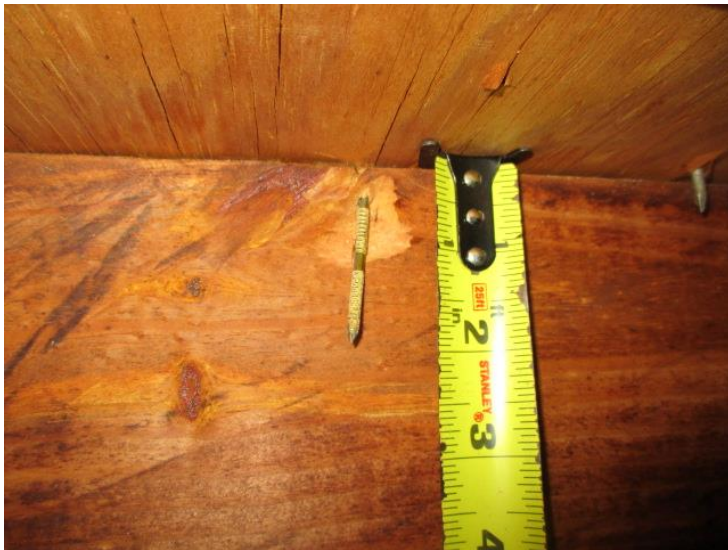
Roof Construction

Comments: | Clips
Inspection verified embedded straps fastened with a minimum of three nails. |

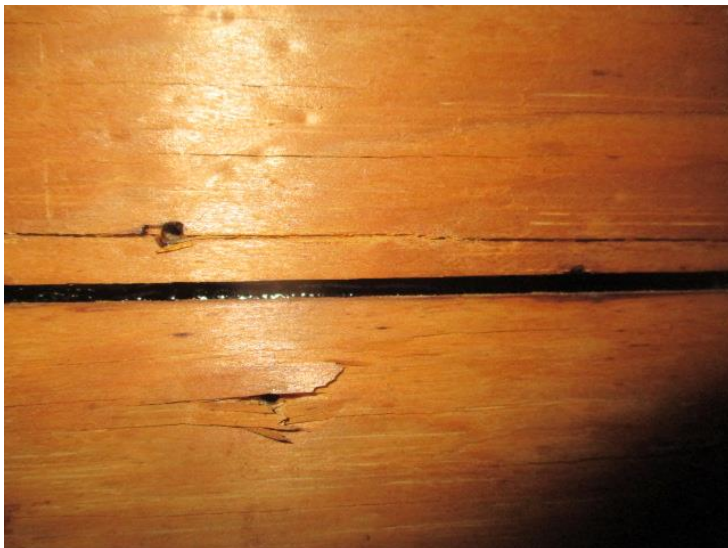
Roof Construction

Comments: | Yes
SWR was verified at time of inspection. The Secondary Water Resistance verified is a self-adhering peel and stick. |

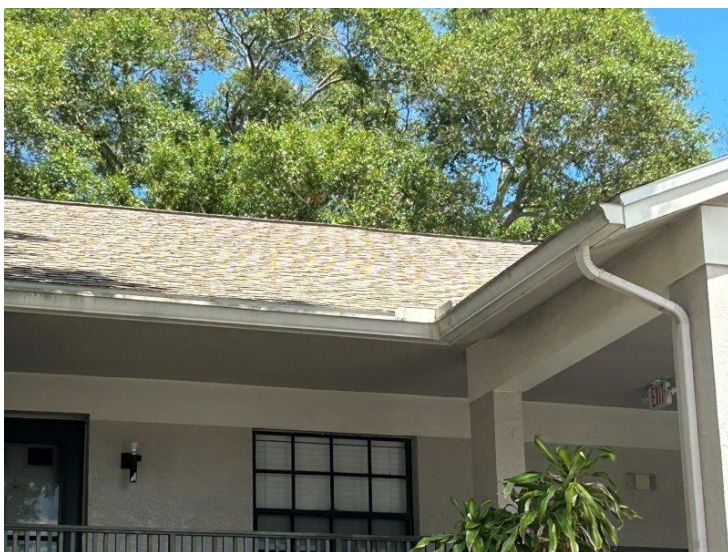
Roof Construction

Comments: | FBC Equivalent
The roof covering was replaced in 2019. The roof permit was confirmed and the permit number is 19-731. This roof was verified as meeting the building code requirements outlined on the mitigation affidavit. |
