Windstorm Mitigation Report (OIR-B1-1802)

Forest Park Condominium Association, Inc. of Dunedin
2188 Elm St. Units 1101-1108
Dunedin, FL 34698

As of 08-26-2024 | FPAT File# MUD2319585

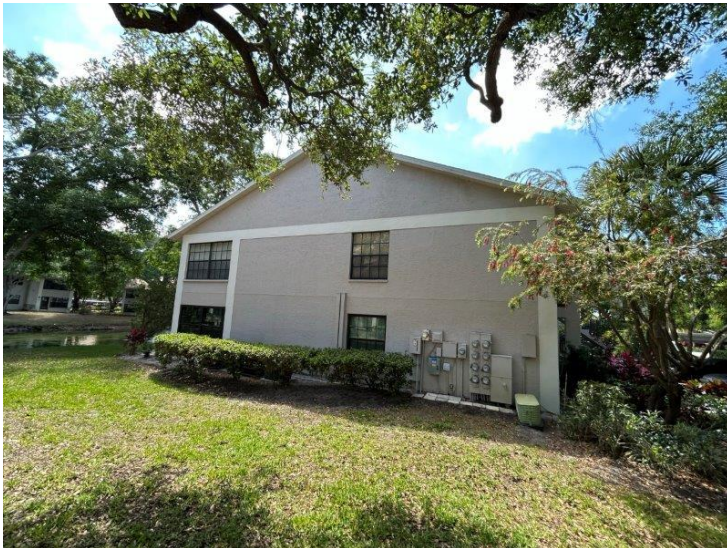
Exterior Elevation

Comments: | Other Roof
Inspection verified a gable roof shape. |

Comments: | None or Some Glazed Openings
Inspection verified some opening protection. Not all glazed openings were protected with impact resistant coverings. |

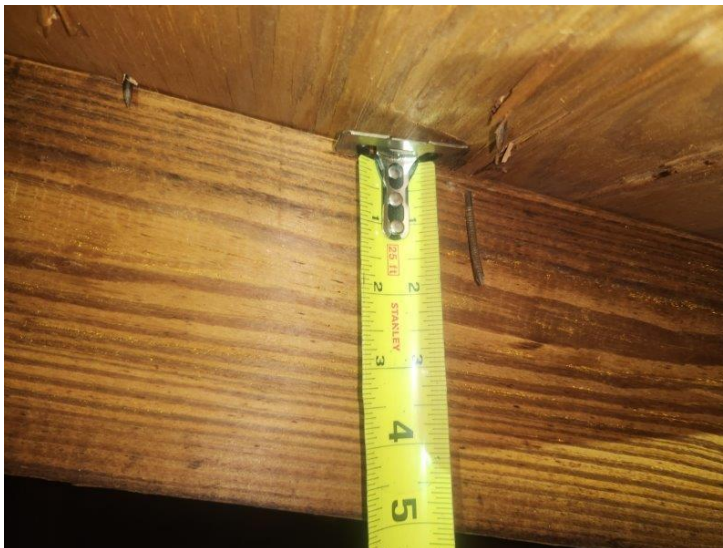
Roof Construction

Comments: | Level C
Inspection verified 1/2" plywood roof deck attached with 8d nails at a minimum 6" on the edge & 6" in the field. |

Comments: | Toe Nails
Inspection verified embedded straps fastened with less than three nails. |

Comments: | Yes
SWR was verified at time of inspection. The Secondary Water Resistance verified is a self-adhering peel and stick. |
