Uniform Mitigation Verification Inspection Form

Inspection Date: 3 - 9 - 2017		
Owner Information		
Owner Name: Forest Park 1 Condo's		Contact Person:
Address: Pool House		Home Phone:
City: Dunedin	Zip: 34698	Work Phone:
County: Pinellas		Cell Phone:
Insurance Company:		Policy #:
Year of Home: Approx. 1988	# of Stories: One	Email:

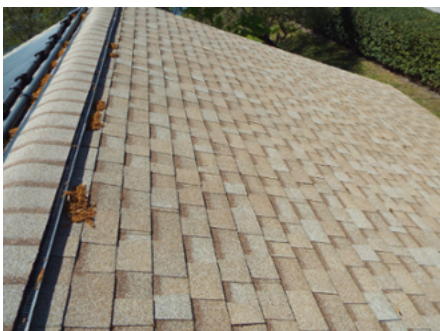
Roof - 1

2.1 Roof Covering Type:	Permit Application Date	FBC or MDC Product Approval #	Year of Original Installation or Replacement	No Information Provided for Compliance
<input checked="" type="checkbox"/> 1. Asphalt/Fiberglass Shingle	7 - 15 - 2016			<input type="checkbox"/>
<input type="checkbox"/> 2. Concrete/Clay Tile				<input type="checkbox"/>
<input type="checkbox"/> 3. Metal				<input type="checkbox"/>
<input type="checkbox"/> 4. Built Up				<input type="checkbox"/>
<input type="checkbox"/> 5. Membrane				<input type="checkbox"/>
<input type="checkbox"/> 6. Other _____				<input type="checkbox"/>

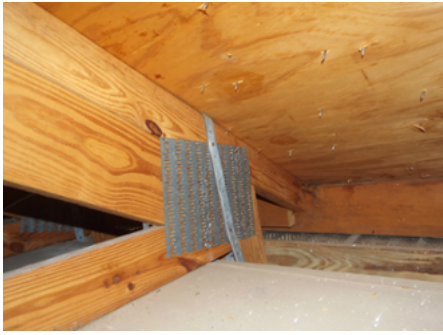
- ☒ Secured to truss/rafter with a minimum of three (3) nails, **and**
- ☒ Attached to the wall top plate of the wall framing, or embedded in the bond beam, with less than a 1/2" gap from the blocking or truss/rafter **and** blocked no more than 1.5" of the truss/rafter, **and** free of visible severe corrosion.
- ☒ B. Clips
 - ☒ Metal connectors that do not wrap over the top of the truss/rafter, **or**
 - ☐ Metal connectors with a minimum of 1 strap that wraps over the top of the truss/rafter and does not meet the nail position requirements of C or D, but is secured with a minimum of 3 nails.
- ☐ C. Single Wraps

Clip

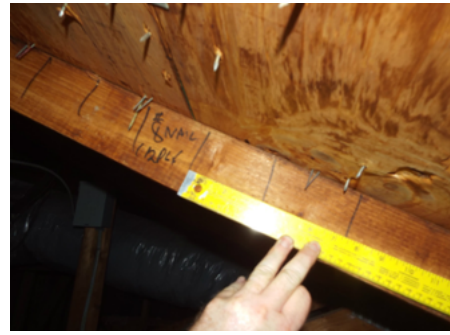
- ☒ C. Plywood/OSB roof sheathing with a minimum thickness of 7/16" inch attached to the roof truss/rafter (spaced a maximum of 24" inches o.c.) by 8d common nails spaced a maximum of 6" inches in the field. -OR- Dimensional lumber/Tongue & Groove decking with a minimum of 2 nails per board (or 1 nail per board if each board is equal to or less than 6 inches in width). -OR-

Nail Spacing

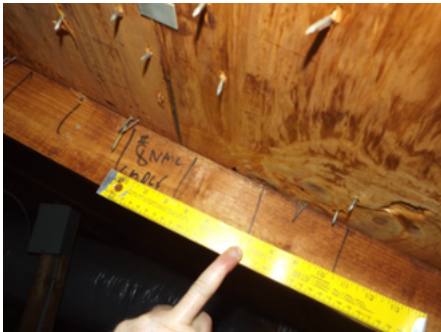
Nail Spacing - 2

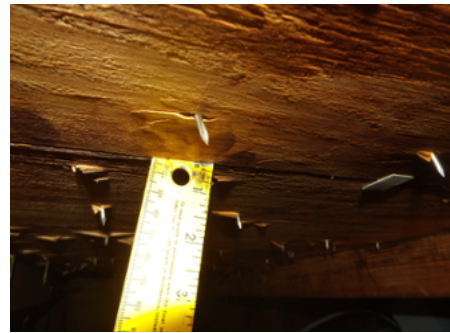
Plywood Width

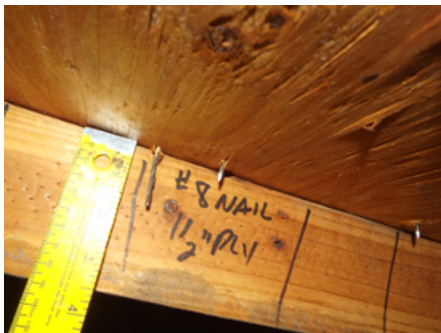
Nail Length

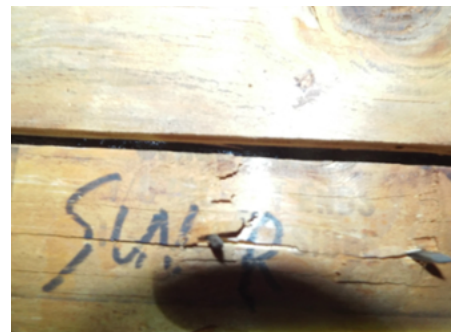
- ☒ A. SWR (also called Sealed Roof Deck) Self-adhering polymer modified-bitumen roofing underlayment applied directly to the sheathing or foam adhesive SWR barrier (not foamed-on insulation) applied as a supplemental means to protect the dwelling from water intrusion in the event of roof covering loss.
- ☐ B. No SWR.
- ☐ C. Unknown or undetermined.

SWR
